RECONNAISSANCE OF THE SHURTZ LAKE LANDSLIDE, UTAH COUNTY, UTAH

*F.X. Ashland
Utah Geological Survey*

REPORT OF INVESTIGATION 234 **July 1997**
UTAH GEOLOGICAL SURVEY
a division of
UTAH DEPARTMENT OF NATURAL RESOURCES

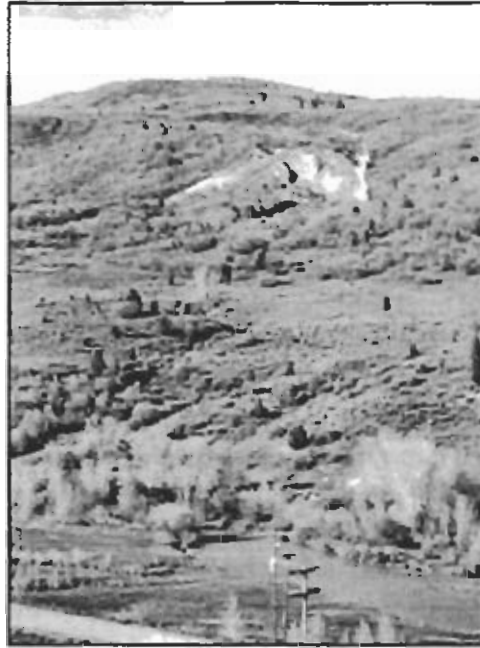
Figure 2. The Shurtz Lake landslide on May 9, 1997. View is to the south from Utah Highway 6. Spanish Fork River is visible in bottom of photograph.

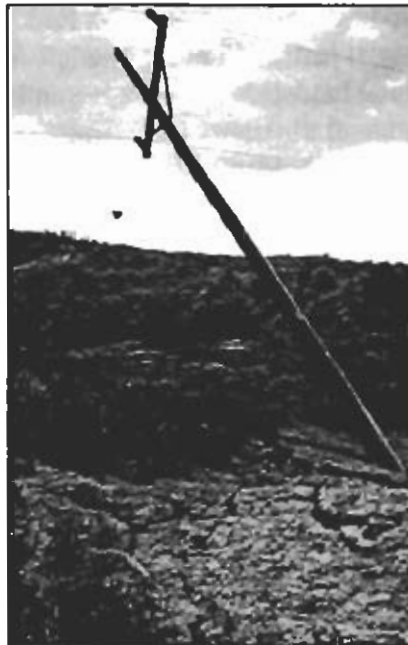
Figure 3. Transmission pole tilted by landslide movement. Pole is one of two in upslope set of Utah Power & Light (UP&L) transmission poles on landslide. Downslope movement caused one of three powerlines to be severed from pole. Powerlines were subsequently abandoned by UP&L.

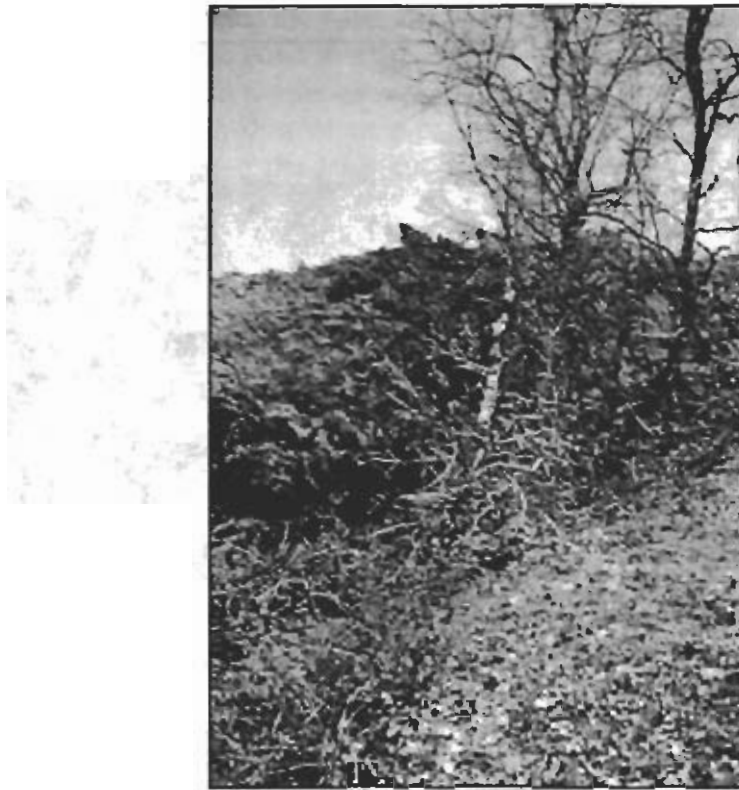
Figure 4. Lateral levee along northwestern edge of left-flank earth flow. Levee is about 10 to 15 feet high.

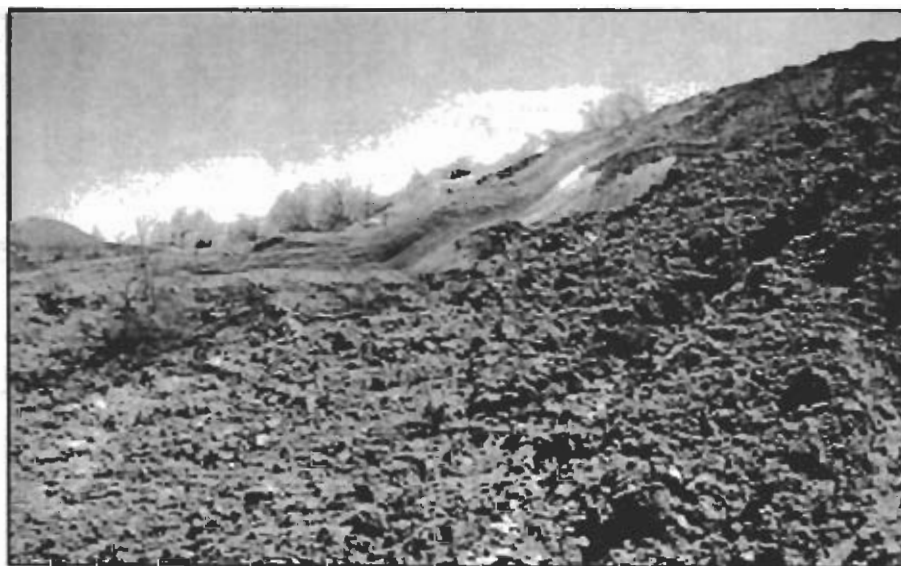
Figure 5. Left-side earth flows. View is to the east from on top of left-flank lateral levee. Inside of opposite earth-flow levee shows ground-parallel slickenlines indicating direction of flow.

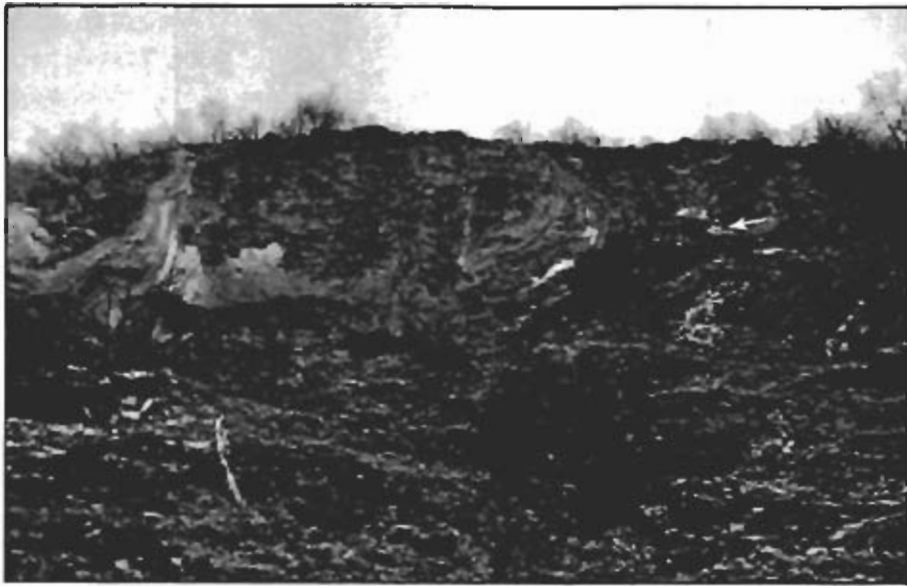
Figure 6. Main scarp of left-flank earth flow. Scarp height exceeds 50 feet. Note geologist (arrow) for scale.

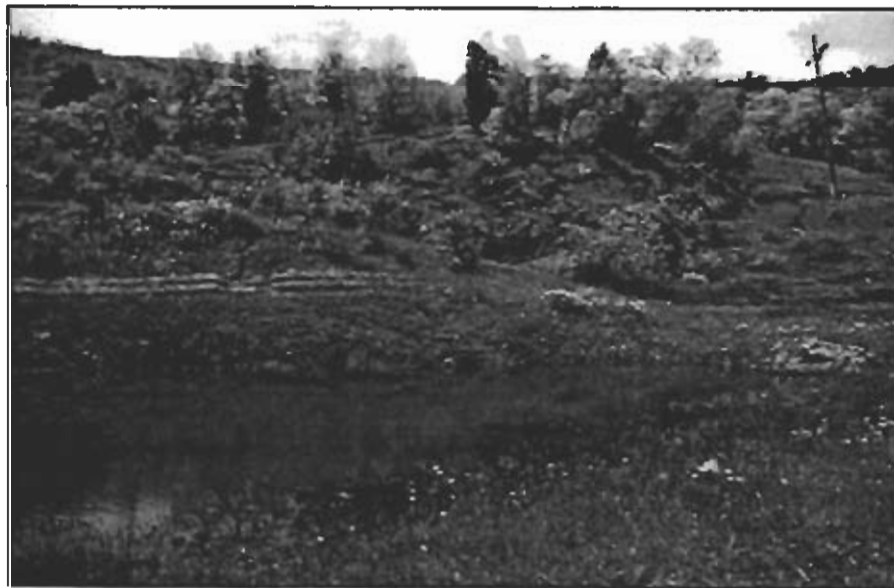
Figure 7. Deformed soil and vegetation downslope of left-side earth flows. Earth-flow deposits are directly upslope of trees near top of photograph. Note intense ground cracking and steep downslope tilt of leading edge of deformed materials. Note also tilt of power-line access road (center left) and transmission pole (upper right).

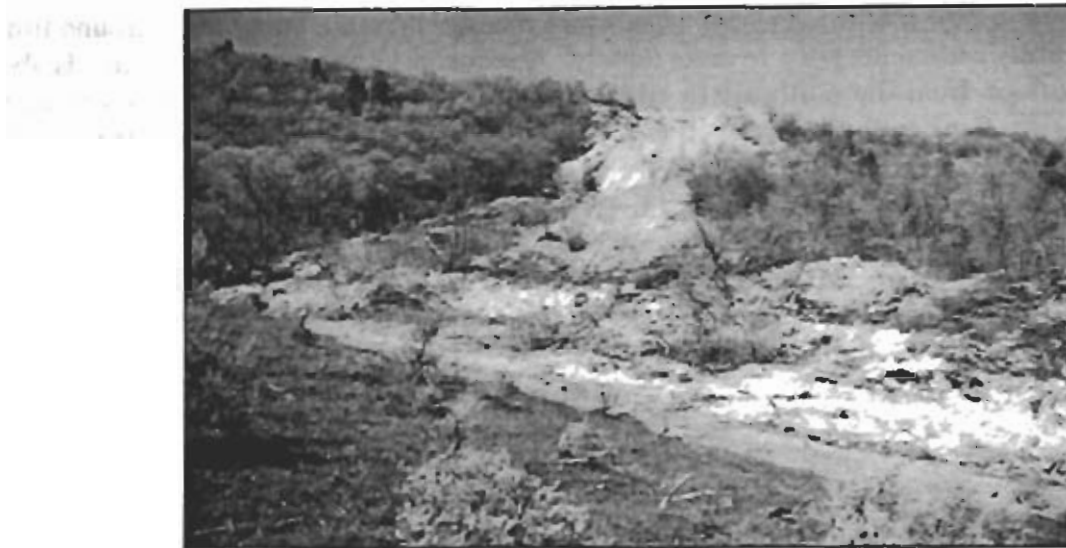
A third earth flow exists along the right flank of the landslide (figure 8). Its head is about the same elevation as that of the left-side earth flows but the right-flank earth flow appears to be slightly longer. Lateral levees similar to those bounding the left-flank earth flow exist on both sides of the upper part of the right-flank earth flow. Near the top of the earth flow, the partially exposed slip surface is curvilinear and irregular. The earth-flow deposits bifurcate, with the main body of the earth flow bending to the north with its tip in a cattle pond which was completely drained by May 9. Loose pond-bottom vegetation was displaced around the tip of the earth flow in the pond,

Figure 8. Right-flank earth flow. View is to south-southwest from near the toe of the deposits.

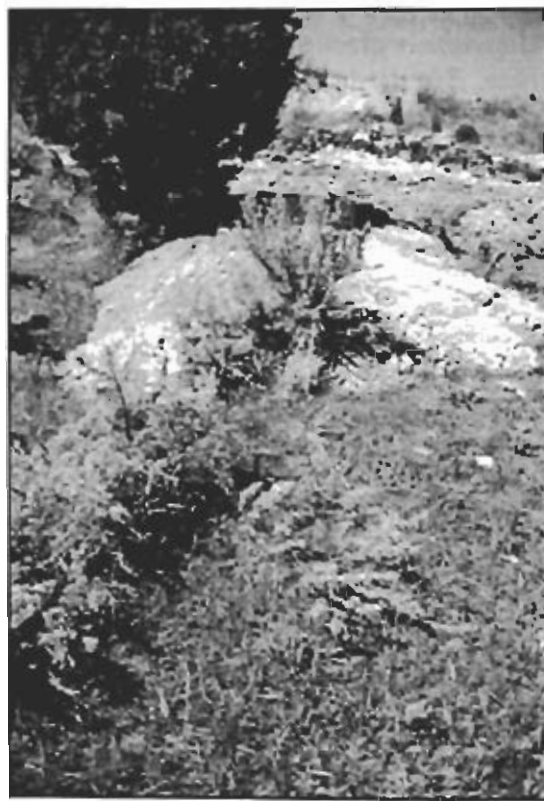
Figure 9. Small finger extending northeast from main body of right-flank earth flow. View is to south-southwest. Water continued to drain from base of earth flow on May 30, 1997.

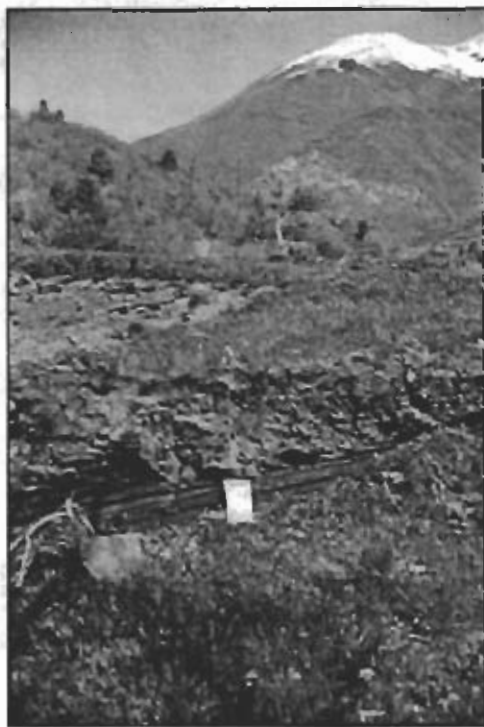
Figure 10. Ground deformation directly downslope of right-flank earth flow. View is to northwest. Ground has heaved upward about 24 inches. Note nearly horizontal slickenlines behind field book indicating earliest movement of heaved block was downslope parallel to ground surface. Dry cattle pond behind scarp was drained as ground tilted and cracked. Field book is 7-1/2 inches high.

At least one pre-existing pond was drained and another is in jeopardy of being drained by the landsliding (figures 10 and 11). A cattle pond on the right flank of the slide was drained because of ground tilting and cracking. A second small pond is located directly downslope of the power-line access road and southeast of the northwesternmost set of transmission poles. Deformed soils directly upslope of the pond appeared to be gradually encroaching on it. In addition, longitudinal ground cracks downslope of the pond could eventually propagate upslope and drain the pond.

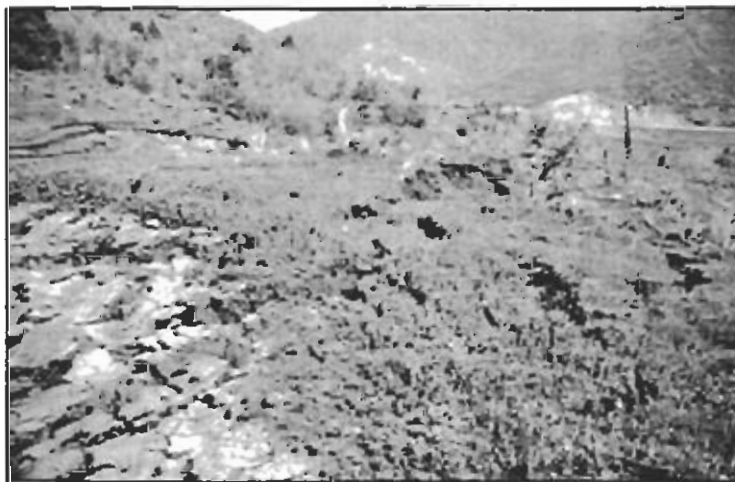
Figure 11. Ground deformation directly downslope of drained cattle pond. View is to northwest. Ground to right of cattle pond was displaced by upslope earth-flow deposits and coherent slide blocks (see figure 10). Intense ground cracking likely contributed to rapid draining of cattle pond.

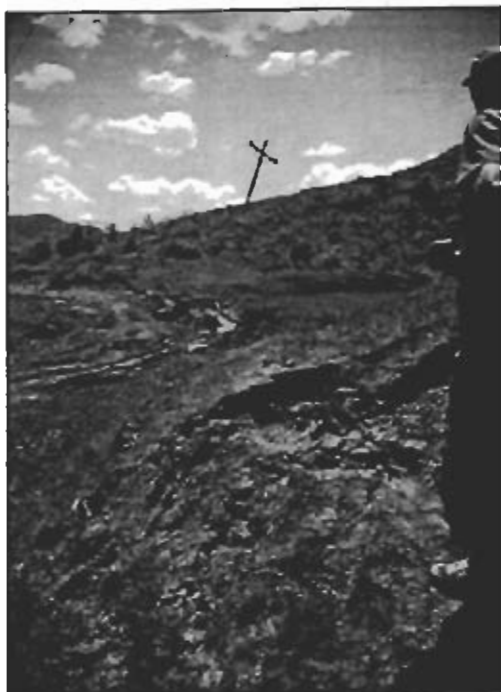
Figure 12. Ground tilting and cracking downslope of left-side earth flows. View is to southeast. Power-line access road (below geologist's foot) was tilted to nearly vertical between May 6 and 9, 1997. Transmission pole shown in figure 3 is visible in distance.

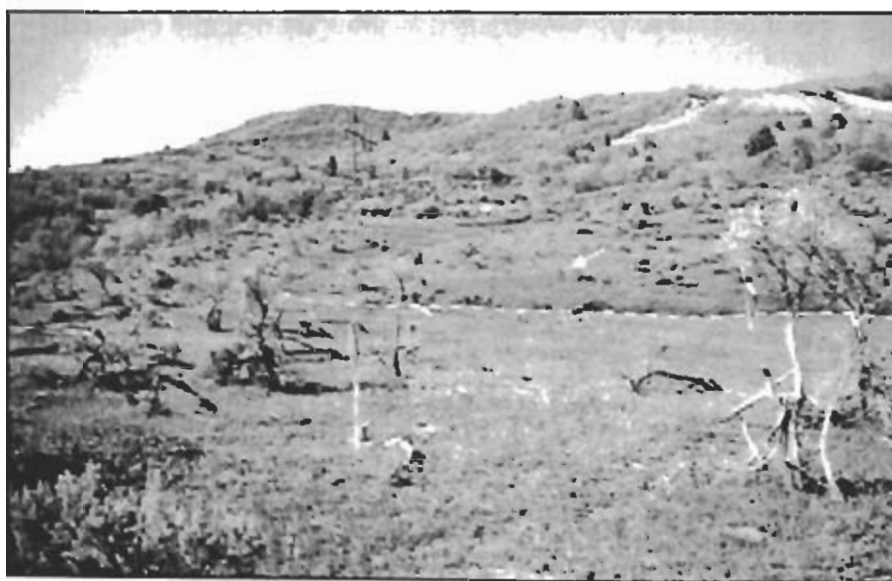
Downslope of the deformed soils, contractional features consist of a series of mostly downslope-directed thrusts (figure 13) involving topsoil and shallow soils. Through May 19, several stacked thrust sheets existed between the downslope edge of the deformed deposits below the earth flows and the toe of the landslide. The downslope set of UP&L transmission poles are founded in soils that were thrust downslope. Downslope displacement of the northwesternmost of these poles is directly related to the thrusting, and was estimated on May 9 to be about 38 feet. In addition, vertical uplift in the vicinity of the poles ranged from 6 to 8 feet (Scott Burton, UP&L, verbal communication, May 9, 1997). Heights of individual thrust-sheet fronts ranged from several inches to several feet. Topsoil at the leading edge of the thrust sheets is commonly folded. Fold axes trend generally parallel to the leading edge of the thrust sheets and perpendicular to the direction of thrusting. A few upslope- and side-directed thrusts exist between and slightly downslope of the deformed deposits below the earth flows.

Figure 13. Thrusting at toe of landslide on May 7, 1997. Stake in foreground is on original ground surface downslope of slide. Stake in distance (arrow) is near tip of slide on lowest thrust sheet. Dashed line indicates lowest thrust. View is to the south.

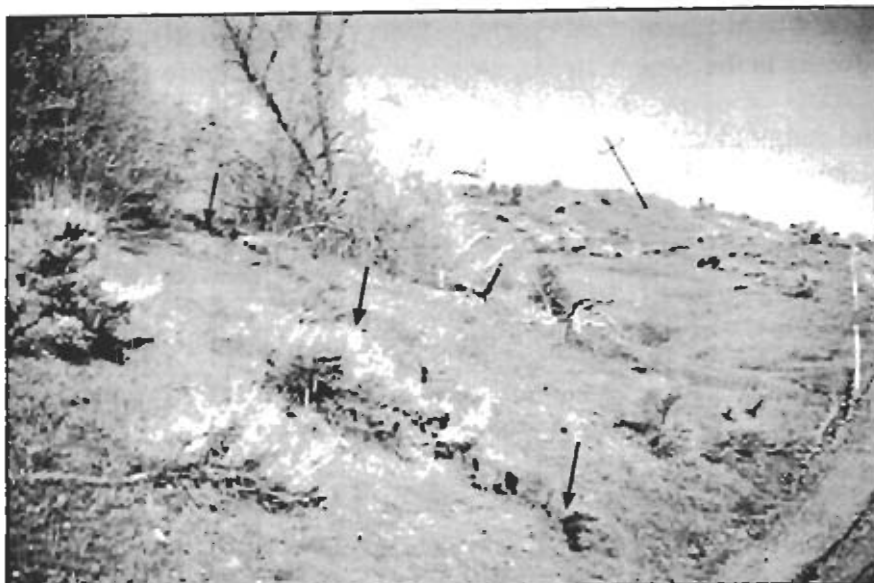
Figure 14. Right-lateral scarp (arrows) upslope of power-line access road. The ground surface on north side of scarp is heaved upward several inches. Note tilt of transmission pole. View is to the west-northwest.

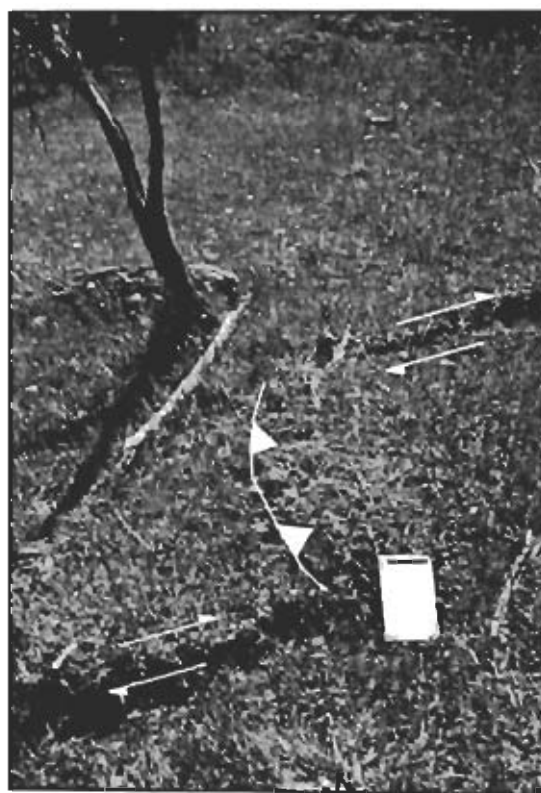
additional longitudinal right-lateral shear cracks or shears. Along a left-stepping set of right-lateral shears thrusting occurs in the zone between the shear crack tips (figure 15).

Figure 15. Thrusting between left-stepping en echelon right-lateral shear cracks. Topsoil to right of thrust has moved toward left over original ground surface.

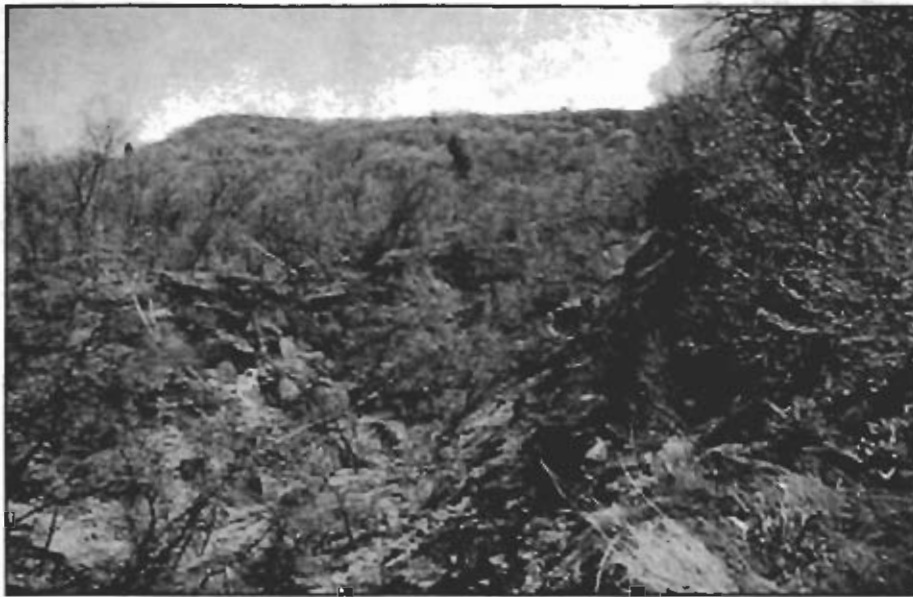
Upslope of the crown of the earth flows is a large area of slumping and extensional deformation that extends for about 1,500 feet upslope to the south. Along the left-flank drainage, slumping into the deeply incised gully (figure 16) continues for about 1,500 feet above the head of the left-flank earth flow. Downdropped slump blocks are visible on both sides of the gully. The landslide is about 600 to 700 feet wide directly above the earth flows but narrows toward the head. This area consists of relatively coherent soil blocks separated by ground cracks or scarps (figure 17), suggesting lateral spreading as the dominant style of ground deformation. Visual estimates of an offset tree line on the right flank of the upper part of the slide suggest a combination of downslope movement and extension on the order of 30 to 50 feet. The main scarp (figure 18) of the landslide ranges between about 10 and 40 feet high and is about 200 to 300 feet across. The head of the landslide is in a relatively gently sloping area where the average slope is less than 20 percent and local slopes are considerably flatter. The crown of the landslide, last observed on May 19, is about 200 feet upslope and south of where the left-flank drainage enters the slide area from the southwest. At the point of intersection of the drainage and the landslide, the drainage is generally incised less than 5 feet. Water was flowing in the drainage and into the left side of the landslide throughout the month of May (figure 19).

Figure 16. Slumping along the left-flank gully upslope of the crown of the left-flank earth flow. View is to the south.

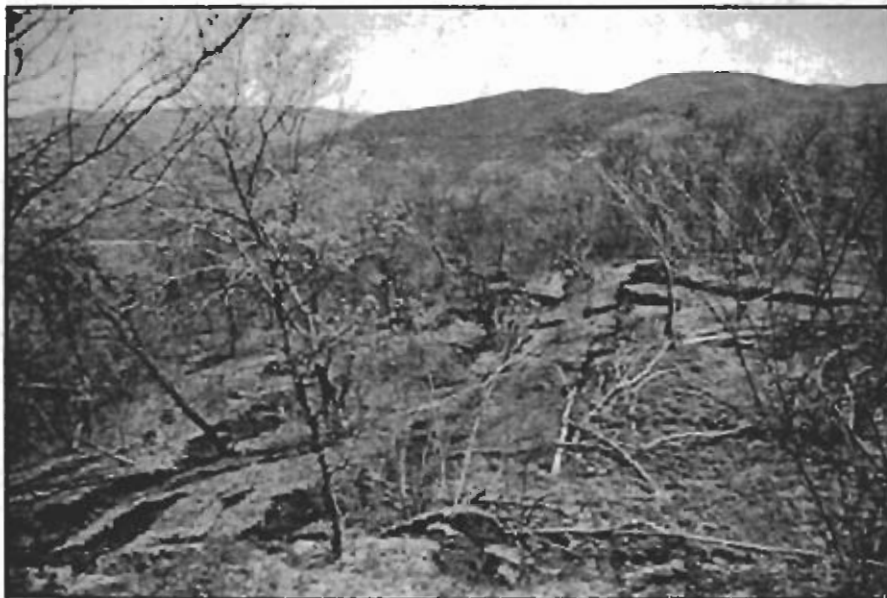
Figure 17. Ground cracks and scarps in the upper part of the landslide indicating lateral spreading. View is to the east.

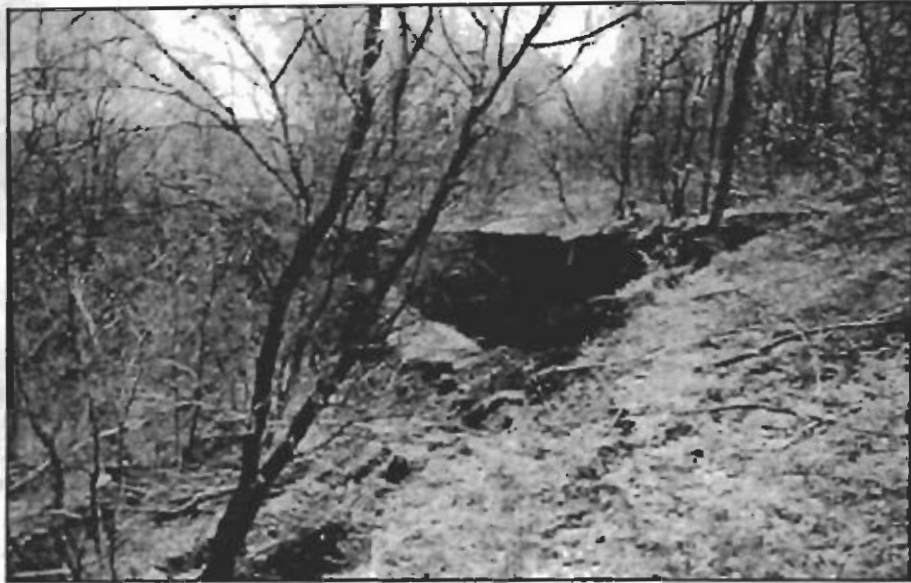
Figure 18. Main scarp of landslide. Scarp height ranges from approximately 10 to 40 feet. View is to the southeast.

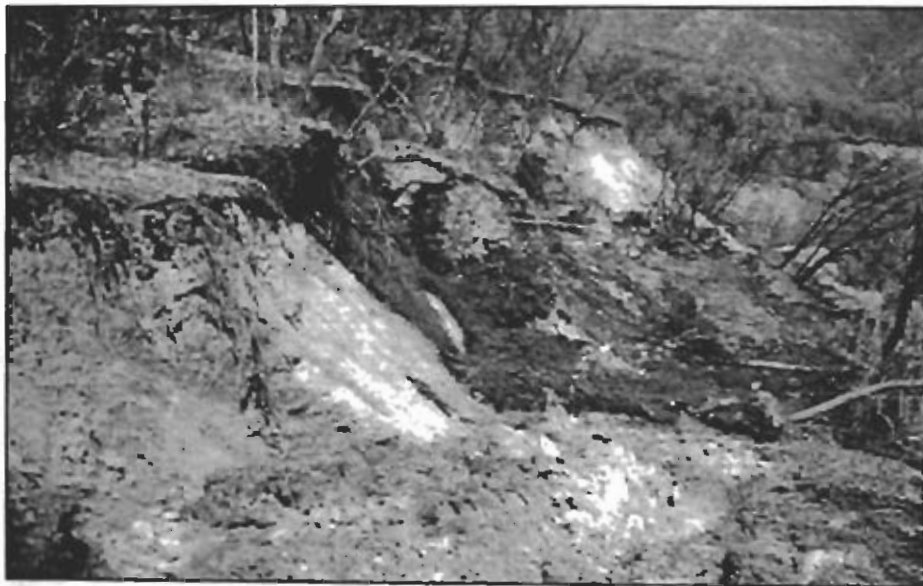
Figure 19. Intersection of left-flank drainage with left-flank of landslide. Geologist (upper left corner) stands next to drainage. Water flowed into slide mass throughout the month of May. View is to the north.

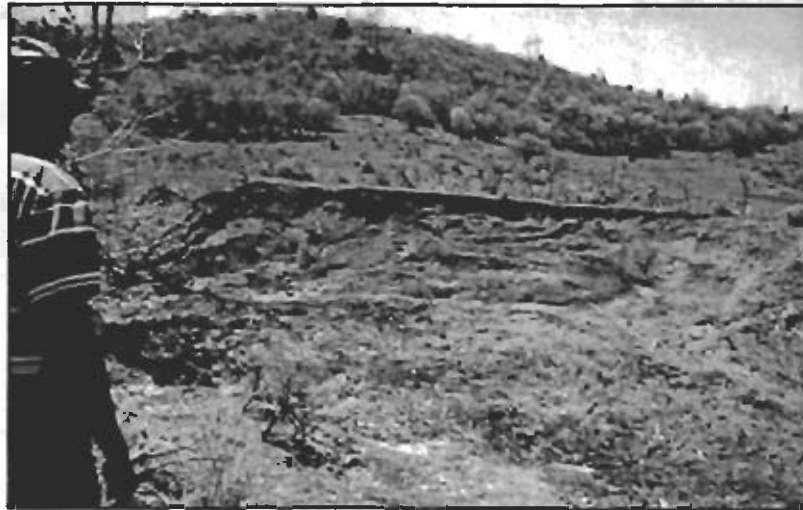
Figure 20. Local slump below the Shurtz Lake landslide in the left bank of the left-flank drainage. Slumping into gully may have been caused by rapid downcutting in early May. View is to the west.

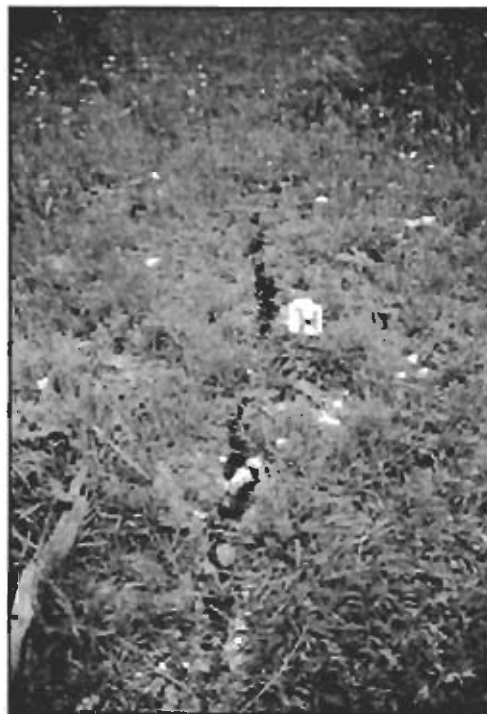
I observed ground cracks (figure 21) and minor scarps over 200 feet downslope and northeast of the May 7 toe of the landslide. Cracks and scarps along the slopes of the central drainage could be followed for several hundred feet downslope and across the foot of the youngest of the

Figure 21. Ground crack observed on May 30 over 200 feet downslope of May 7 toe of landslide. Deformation suggests distribution of landslide activity is enlarging and progressing downslope. Cracks likely formed following heavy precipitation over the Memorial Day weekend. Field book is about 7-1/2 inches long.

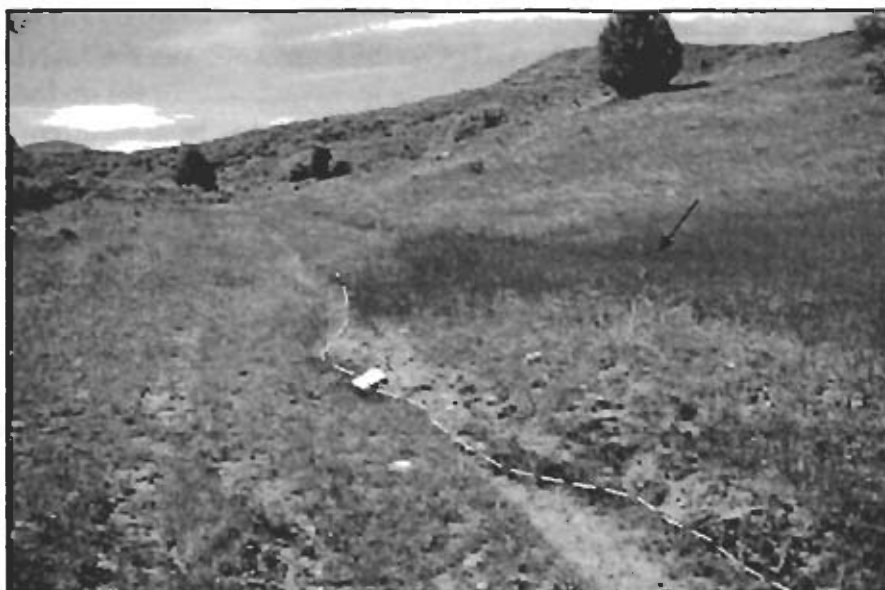
Shallow thrusts (figure 22) of topsoil and shallow soil exist in several locations at the toe of the oldest prehistorical landslide deposits that abut the D&RGW railroad grade. Topsoil was generally thrust several inches to several feet downslope over the original ground surface. In one location, an old four-wheel-drive road was deformed by a thrust so that the upslope rut was moved to within a foot of the downslope rut. Seeps exist in the vicinity of most of the thrusts. Ground cracks and scarps were visible upslope of the thrusts (figure 23). These features suggested thrusting at the railroad grade level may have been caused by local slumping at the toe of the older prehistorical landslide deposits, perhaps unrelated to the May 6 landslide. However, an association of this slumping with ground cracks farther upslope suggests a cause-and-effect relationship. For instance, slumping at the toe could be caused by oversteepening of the lower part of the slope as a result of gradual deep-seated movement and increased pore pressure following the May 6 landslide and the Memorial Day weekend precipitation.

Figure 22. Thrusting in older landslide deposits abutting abandoned D&RGW railroad grade. Topsoil and underlying soil (on right) has been thrust over upslope rut. Field book is near tip of thrust sheet. Note wet soil and darker vegetation (arrow) directly upslope of thrust indicating seepage. View is to the south.

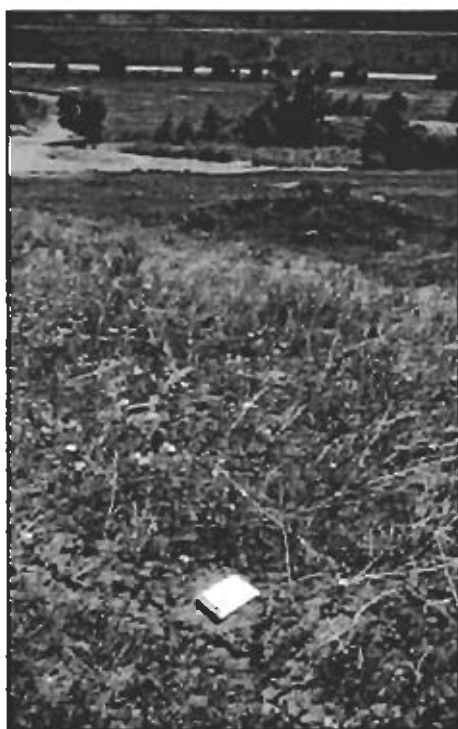
Figure 23. Scarp upslope of thrusts near abandoned D&RGW railroad grade. Note proximity of landslide deformation to Spanish Fork River (near top of photograph) on May 30, 1997. Field book is about 7-1/2 inches long. View is to the northeast.
